The Detrimental Effect of a Rubber O-Ring on a 10-32/10-32 Cable Connection

by: Adam Coghill, Applications Engineer

ENDEVCO TP 313

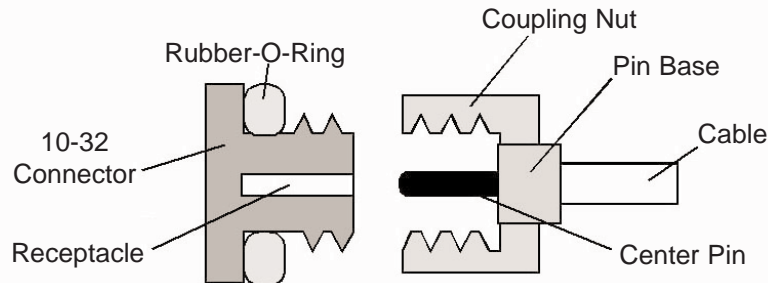
Anatomy of a typical connection between a 10-32 connector and an accelerometer's cable

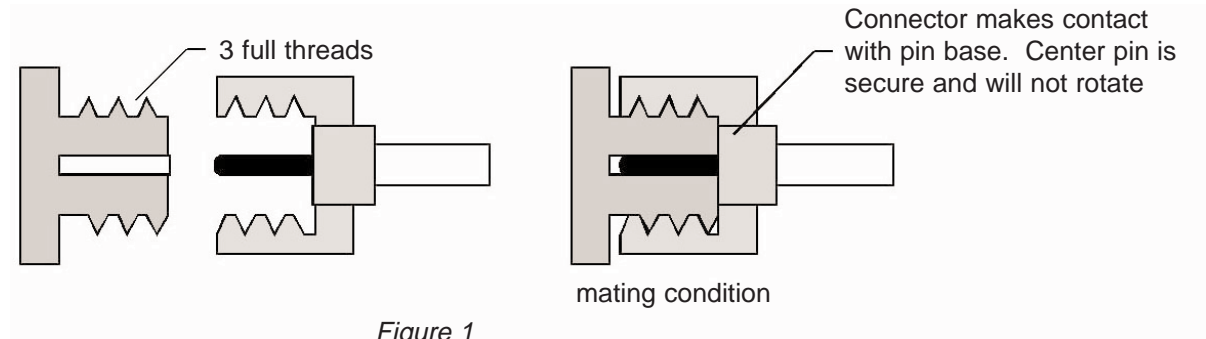
Figure 1 illustrates an ideal accelerometer/cable connection. There exists no rubber o-ring and there are three complete threads engaged. The cable's pin base is in direct contact with the corresponding surface on the 10-32 connector. This coupling design is critical for maintaining good contact during vibration and has been the standard configuration on all Endevco transducers. This ideal type of connection, however, is usually never found at the signal conditioner end.

Having three complete threads on both a coupling nut and a 10-32 connector helps to reduce the risk of the coupling nut coming loose. The more threads there are engaged on a connector, the better the chances are of a coupling nut staying fastened. When a coupling nut is fastened to a connector with the recommended torque (finger-tight with 1.5 in.-lbs.), the threads exert friction on one another, giving rise to a moment that resists vibrational forces that attempt to loosen the nut. One way to increase the friction between the threads is to simply increase the number of threads. Endevco has three complete threads on all of its transducers. Most of the signal conditioners available from Endevco and its competitors, however, have connectors with only two complete threads. This is due to the fact that vibration is not usually an issue at the conditioner end.

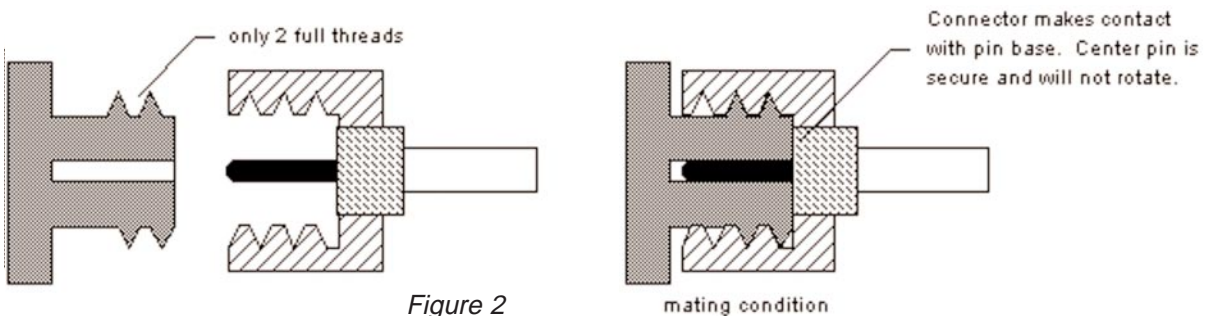
Figure 2 shows a connection that is acceptable only under low-level vibration. Note that there is no o-ring present. Connectors that incorporate o-rings typically only have two complete threads. The engagement of two complete threads will normally provide enough friction to keep the coupling nut fastened at lower vibration levels.

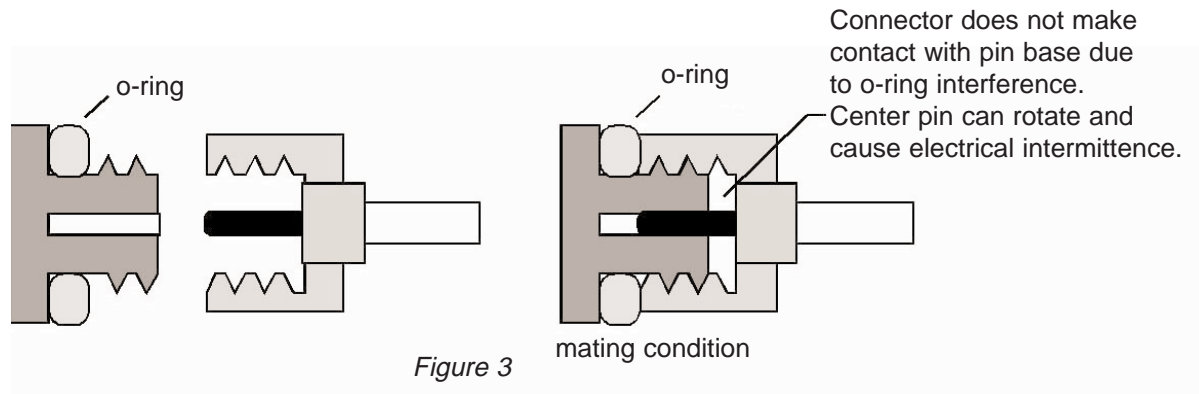
Figure 3 shows the problem that o-rings can cause. With the same connector shown in Figure 2, the o-ring doesn't allow the coupling nut to be completely fastened onto the 10-32 connector. As a result, the pin base isn't allowed to contact the connector. Because of this, the pin base cannot exert the friction necessary on the connector to prevent its integral center pin from rotating. In this type of a situation, intermittent center-pin contact is inevitable, causing electrical noise in the output signal.

Endevco recommends that whenever you encounter a 10-32 connector that has an o-ring, get rid of the o-ring.

To prevent the chances of an intermittent output signal from a connection, it is absolutely necessary that a cable's pin base be in direct contact with the associated 10-32 connector.
